ST. ANTHONY  
FALLS LABORATORY

**Project Report No. 576**

***Assessing Iron-Enhanced Swales for  
Pollution Prevention***

Final Report

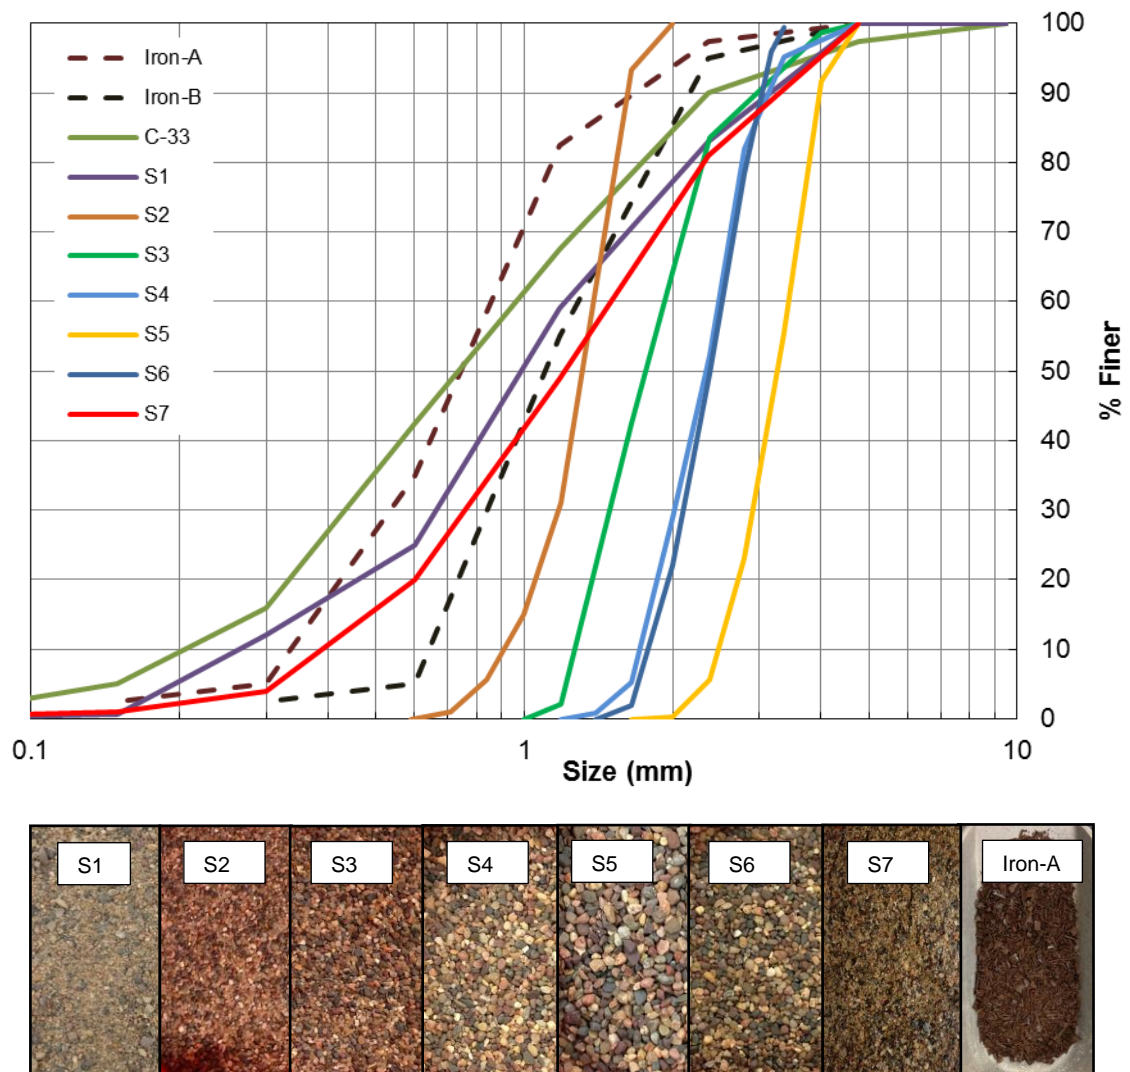
**Figure 1. Particle size distribution and photographs of the sand and iron shavings samples tested for application as filter media in the iron-enhanced ditch check. The particle size distribution of C-33 sand is provided for reference.**

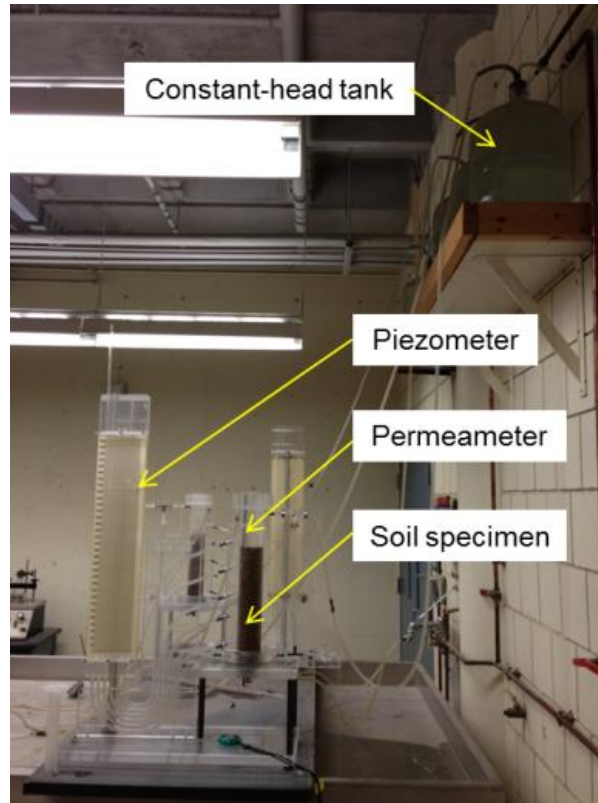
**Figure 2. Constant-head permeability test setup used for measuring the saturated hydraulic conductivities of sand samples.**

In the constant-head test, a weighed quantity of media was filled into a 6 cm (2.4 inches) diameter permeameter column in incremental quantities, compacted using a hand tamper tool at each increment, and filled to a total height of 30 cm (12 inches) in the column. Tap water was passed from the top of the column and allowed to saturate the media. Periodic measurements of piezometric water level at various sections of the column and discharge rate were taken. The establishment of constant gradient or steady state condition was indicated by constant readings in the piezometer. The steady-state head and discharge measurements were utilized to compute the saturated hydraulic conductivity of the media using Darcy's law:

The measured  $K_{sat}$  of the sand samples tested ranged between 0.022 and 0.484 cm/s (32 and 686 in/hr) (Table 1). The  $K_{sat}$  values of sand-iron media were lower than the sand-only media due to the fact that the finer iron shavings occupied the interstitial space between sand particles, thereby reducing the overall hydraulic conductivity of the sand-iron mix. No wash-out of iron shavings was observed for the sand-iron mix samples tested. The wash out was tested by collecting the discharge from the column into a small bucket throughout the test period, visually inspecting for presence of iron particles, and re-checking while pouring out the water into a wide metal basin by the test apparatus.

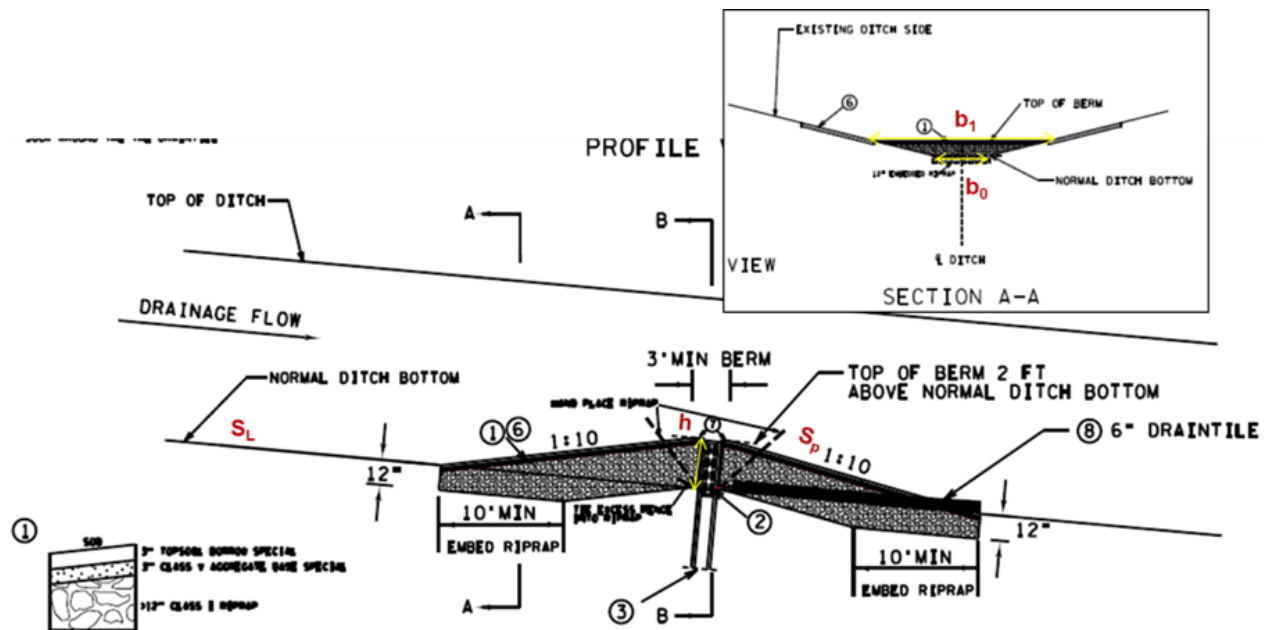
The modeling was done for a hypothetical ditch check, which was based on the preliminary design proposed for the potential study site at the MnDOT swales. The schematic diagram and summary of design parameters of the hypothetical ditch check are provided in Figure 3. The length of filter media in the ditch check is 30.5 cm (12 inches) in the direction of flow.

Parameters	
Normal ditch bottom slope ( $S_b$ )	1%
Face slope of berm ( $S_p$ )	1:10
Height of berm ( $h$ )	0.46 m (1.5 ft)
Bottom width of ditch ( $b_0$ )	3 m (10 ft)
Width at top of berm ( $b_1$ )	7.9 m (26 ft)

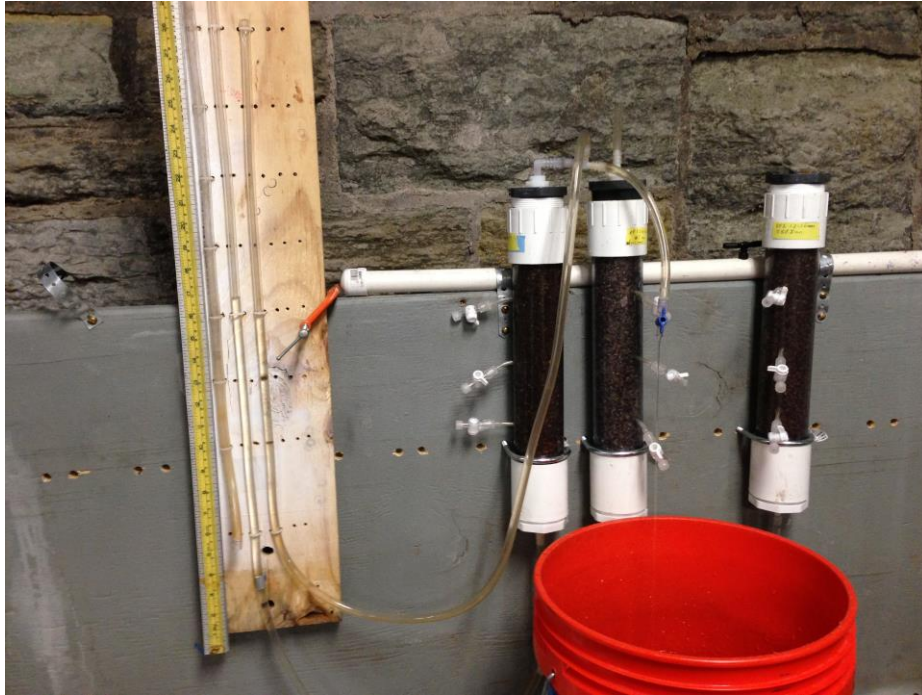
**Figure 4. Column experiment for determining the phosphate removals by the potential filter media selections.**

Column tests were conducted to measure the phosphate removal performances of the filter media choices. Two media mixes were tested: S3-Iron B and S4-Iron B, where the iron content was 7.5% by weight (Figure 4). Iron B, which is a coarser gradation of iron shavings compared to Iron A (Figure 1), was used in the column tests. The 7.5% by weight iron proportion was based on the full-scale design being developed concurrently. A control column consisting of 100% S3 sand was also tested. The media was packed in an upward flow column of 5.04 cm (2 inch) diameter and 38 cm (15 inches) length. Layers of washed-pea gravel (approximately 7 cm thick) and woven geotextile fabric were placed on both ends of the media (~24 cm) to prevent resuspension/wash out of media.

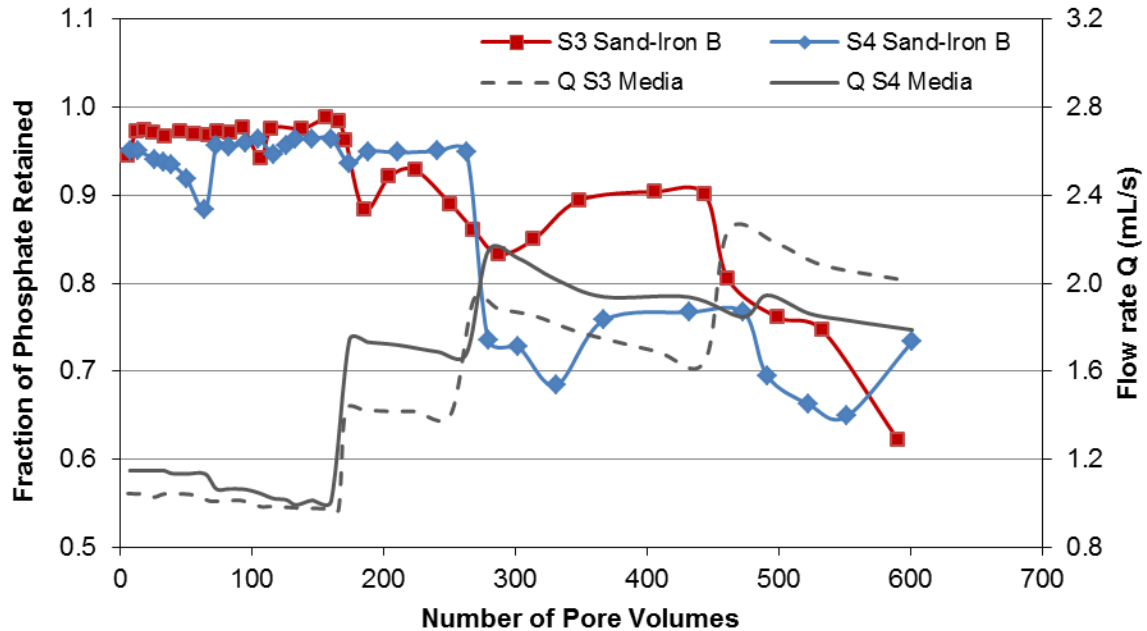
**Figure 5. Results of column tests on the potential media for ditch check filter. Media composition was 92.5% Sand and 7.5% iron (by weight).**

The observed phosphate retentions ranged from 97 to 62% for S3-Iron B media and 95 to 65% for S4-Iron B media during the six tests conducted over two-month period (Figure 5). The control sand-only column showed less than 2% reduction of the input phosphate in the first and second tests, hence further tests on the sand column were not continued.

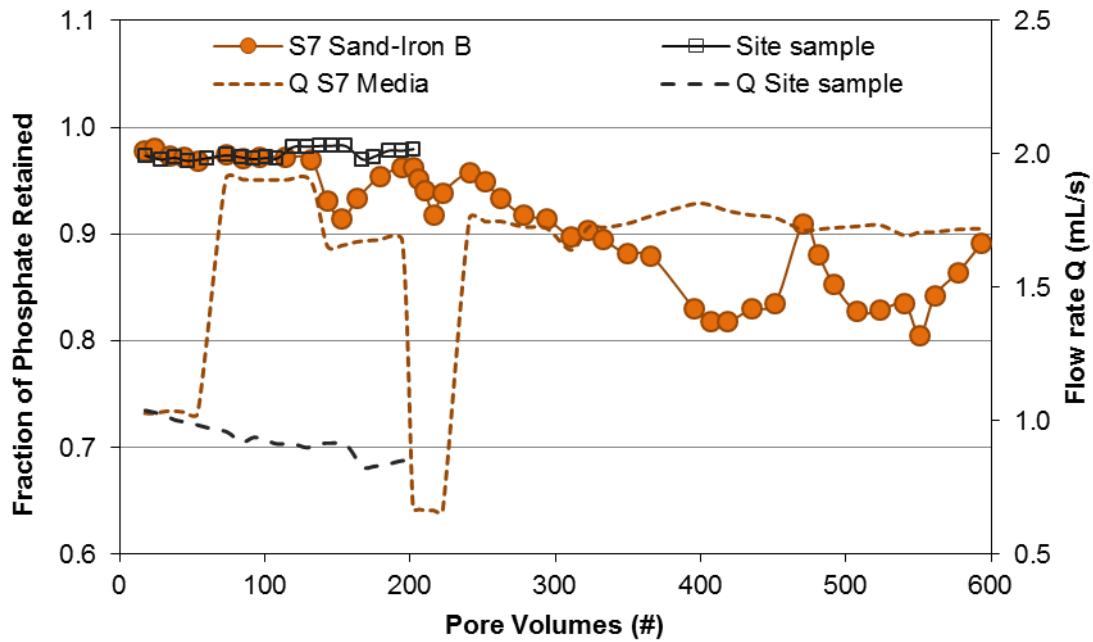
**Figure 6. Column experiment results for filter media, S7 sand-iron B, selected for application in the swale ditch checks. ‘Site sample’ is the media (S7 sand-iron A) actually installed in the MnDOT swale sites. Fraction of phosphate retained =  $\frac{(C_{in}-C_{out})}{C_{in}}$ , where  $C_{in}$  and  $C_{out}$  are the inflow and outflow phosphate concentrations, respectively.**

Column tests conducted on S7 sand-iron B media (iron content 7.5% by weight) showed good phosphate retentions in the media during the two-month test period. The fraction of phosphate retained for the total pore volumes of water passed through the media is shown in Figure 6. For the input phosphate concentration of 200  $\mu\text{g/L}$  and flow rates ranging between 0.83 and 2.5 mL/s in nine tests (total # pore volumes = 598), the media retained 98 to 84% of input phosphate. The average media hydraulic conductivity was measured to be 0.0586 cm/s (83 in/hr). A small reduction in  $K_{\text{sat}}$  of the media was observed during the test course, likely due to rusting of iron that can enable the occupation of pore spaces. Due to the good phosphate removal capability observed, the S7 sand-iron shavings B media was the final choice for application in the iron-enhanced ditch check to be constructed.

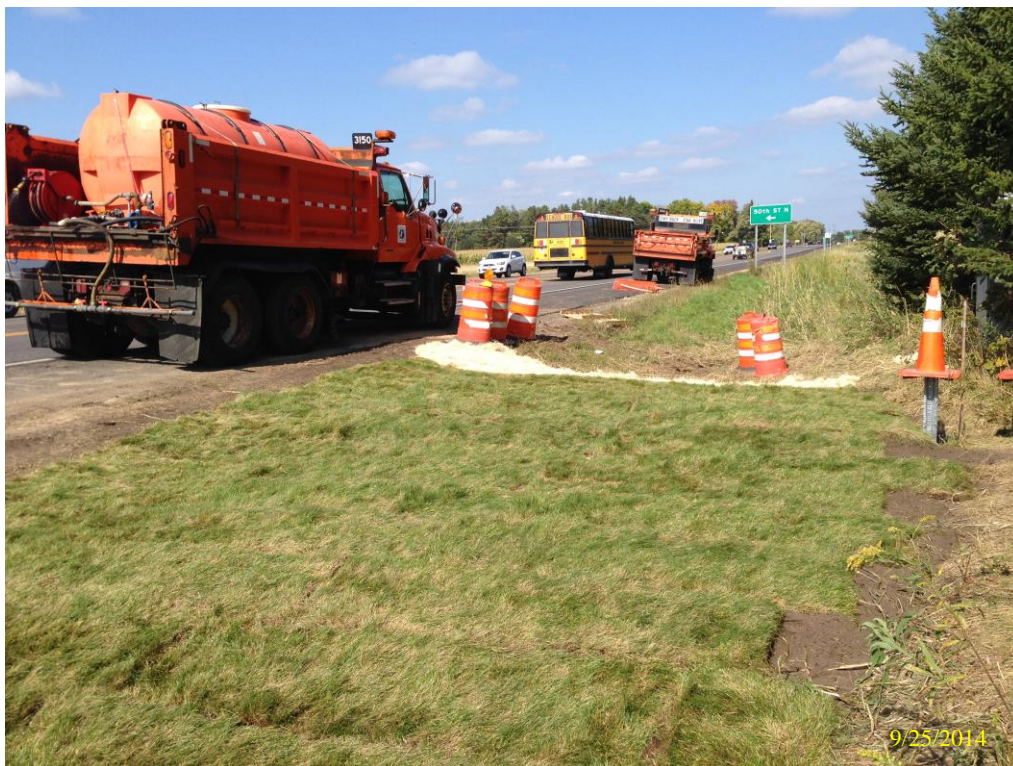
**Figure 8. Photograph of the iron-enhanced ditch check constructed at site 2 of MnDOT swales, TH5, Stillwater.**

The existing ditch checks (soil berms) at sites 1 and 2 were completely dug out and the new iron-enhanced ditch checks were constructed in their place. At site 1, the filter bags were arranged within a metal cage. The void space between and around individual filter bags was filled with loose filter media throughout the installation process. At ditch check site 2, a modified version of the filter was installed. Instead of using several small filter bags, a single geotextile bag was used to contain the filter media. The final filter size in the direction of flow was approximately 0.4 m (17 inches) at both sites. Class I riprap was placed at a 1:10 slope on either side of the filter assembly to build the berm, over which Class V aggregate base was placed to a thickness of 8 cm (3 inches). The gaps between riprap and filter cage fencing were

The overall construction procedure followed was similar for site 1 and site 2, except for the modification in the filter assembly (i.e. multiple filter bags vis-à-vis single bag). The total length of the iron-enhanced ditch check feature is 13 m (44 ft) in the direction of flow, at both site 1 and site 2. The elevation of the ditch checks is 61 cm (2 ft) above the normal ditch bottom. The width across the ditch (perpendicular to flow) is 6 m (21 ft) at site 1, and 4 m (12.5 ft) at site 2. A photograph of the completed iron-enhanced ditch check at site 2 is shown in Figure 8.

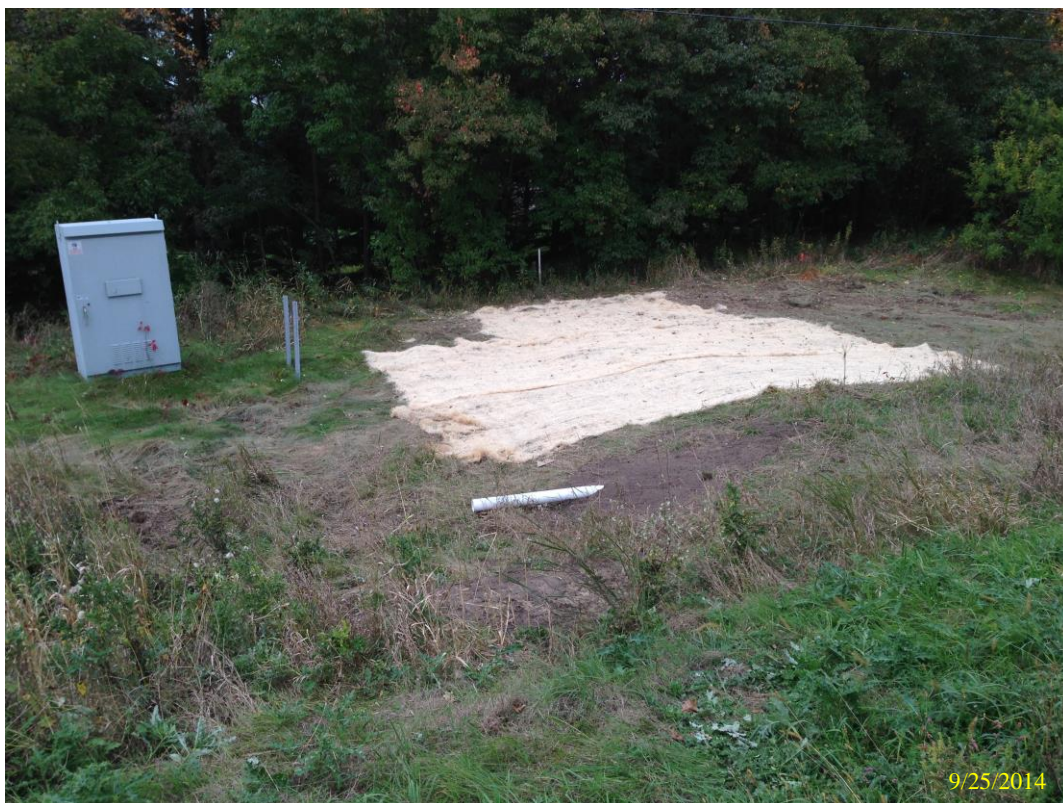
**Figure 9. Existing ditch check at site 3 of MnDOT swales, TH5, Stillwater.**

The construction at Site 3 was mainly “repair”, which involved correcting the soil berm elevation, re-seeding, placement of a new erosion control blanket and installation of a 10 cm- (4 inch-) diameter PVC drain pipe on the downstream end. Monitoring wells were not installed at this location, as done for sites 1 and 2. The drain pipe was used for flow monitoring purpose at this site. Photograph of the repaired ditch check site 3 is shown in Figure 9.

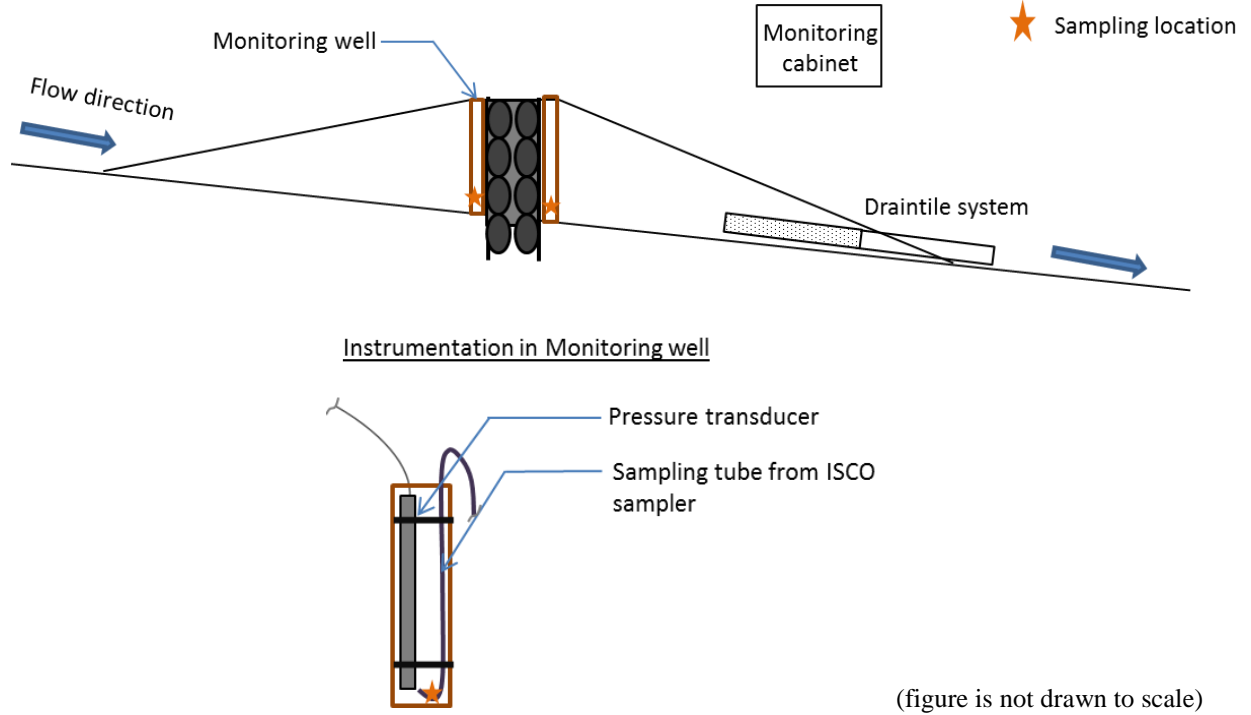
**Figure 10. Layout of the monitoring system at the iron-enhanced ditch check sites 1 and 2 in MnDOT swales.**

the automated 6700 ISCO samplers (Teledyne ISCO, Lincoln, NE). The overall layout of the monitoring system employed at ditch check sites 1 and 2 is shown in Figure 10.

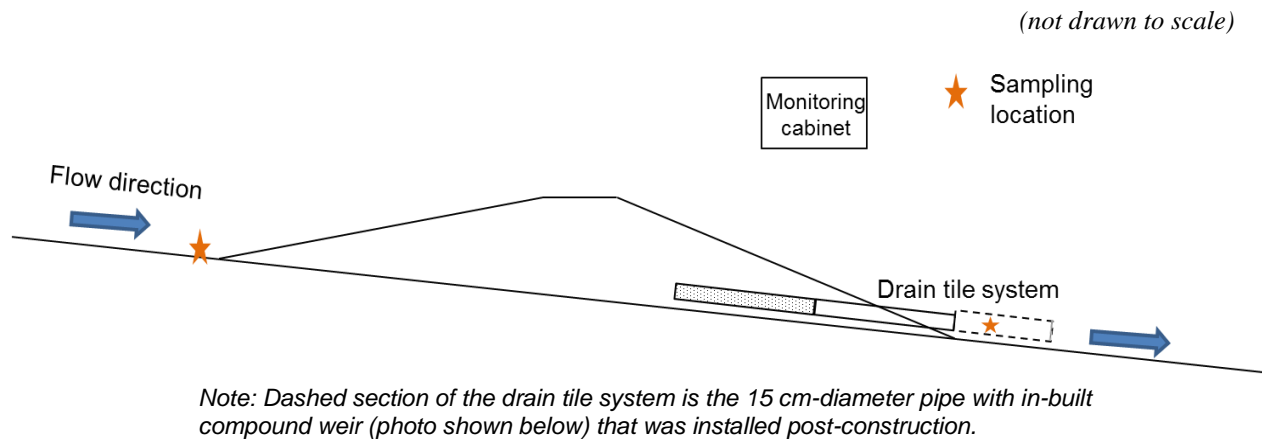
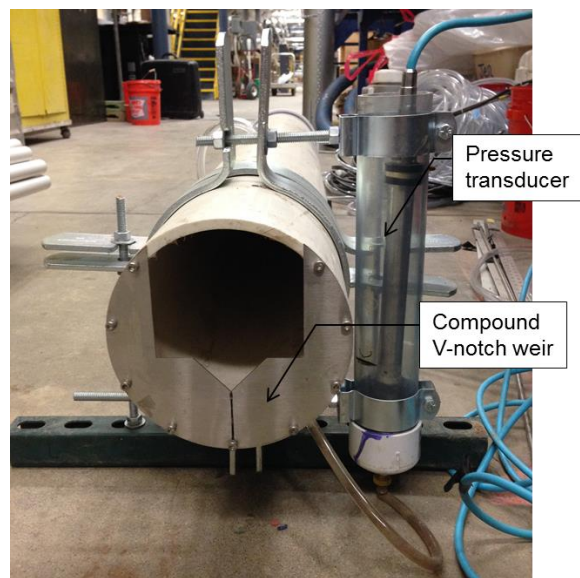
**Figure 11. Monitoring system layout (top) and photograph at SAFL of the compound weir setup for measuring outflow (bottom) at the existing ditch check Site 3 in MnDOT swales.**

At site 3, measurements of flow through the existing ditch check were made in the drain tile on the downstream end. It was assumed that water does not infiltrate underneath the ditch check, and the volumes of runoff entering and leaving the ditch check are the same. Therefore, only the outflow from the ditch check was monitored. A 15 cm (6 inch) pipe section with a compound V-notch weir was constructed and calibrated at SAFL (Figure 11). This pipe section was attached to the existing 10 cm (4 inch) drain tile on site using an eccentric pipe expander. Water level behind the compound weir was measured using INW 9805 pressure transducer installed within the stilling well, and the flow rate computed using the weir calibration equation programmed in the CR1000 data logger. Water quality sampling was performed at the upstream grass channel just before the ditch check (for inflow sample) and at the downstream drain tile (for outflow sample) using ISCO water samplers, as shown in the layout in Figure 11.

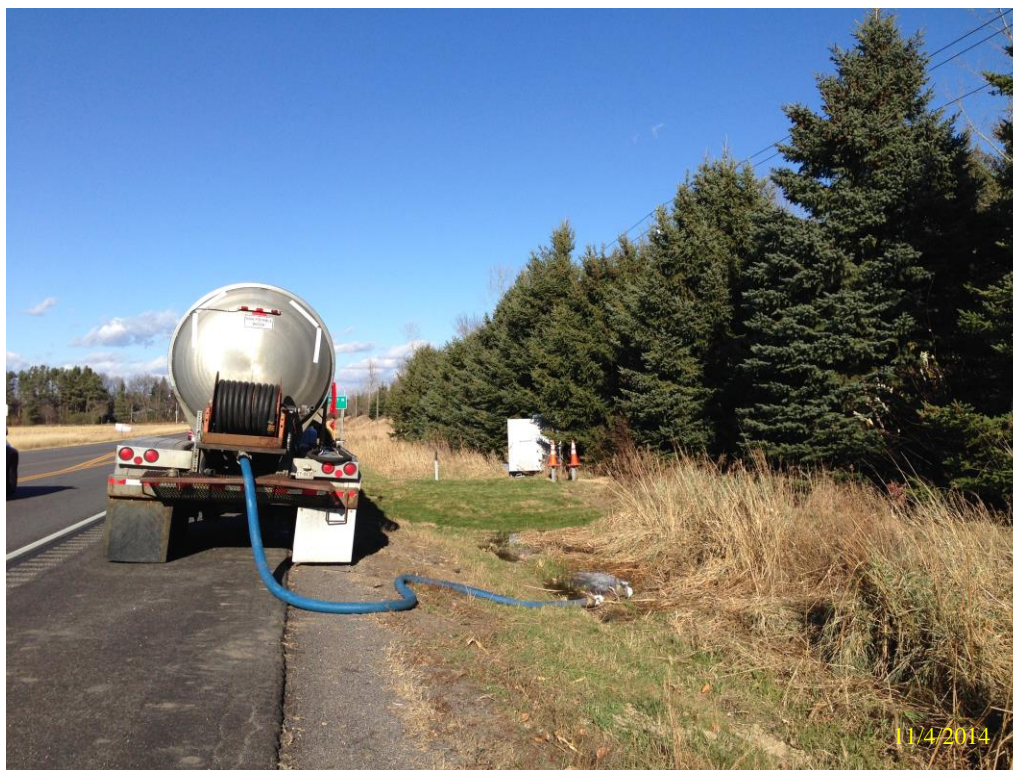
**Figure 12. Photograph showing the water truck testing conducted at MnDOT iron-enhanced ditch check site 2, TH5 swales, Stillwater.**

Rainfall did not occur during the 2014 season after construction was completed at the MnDOT swales. Therefore, field testing using synthetic runoff (Erickson, et al. 2013) was conducted at each site in November 2014 (Figure 12). A water truck of capacity 23 m<sup>3</sup> (6000 gal) was used. Synthetic runoff was generated by dosing the truck water with a chemical solution containing measured amounts of phosphorus and zinc to attain a target concentration of 220 µg/L phosphate and 150 µg/L zinc in the water. A hose was attached to the spout on the back of the water truck to deliver the synthetic runoff into the swales, approximately 3 m (10 feet) upstream of the ditch checks. The water input rate was controlled by the valve on the spout, and a water meter was connected to the hose to quantify the volume of water being input over time. The equipment and sampling program designed for storm monitoring (described in ‘monitoring method’ section) were utilized to record flows and collect inflow and outflow water samples during the water truck testing.

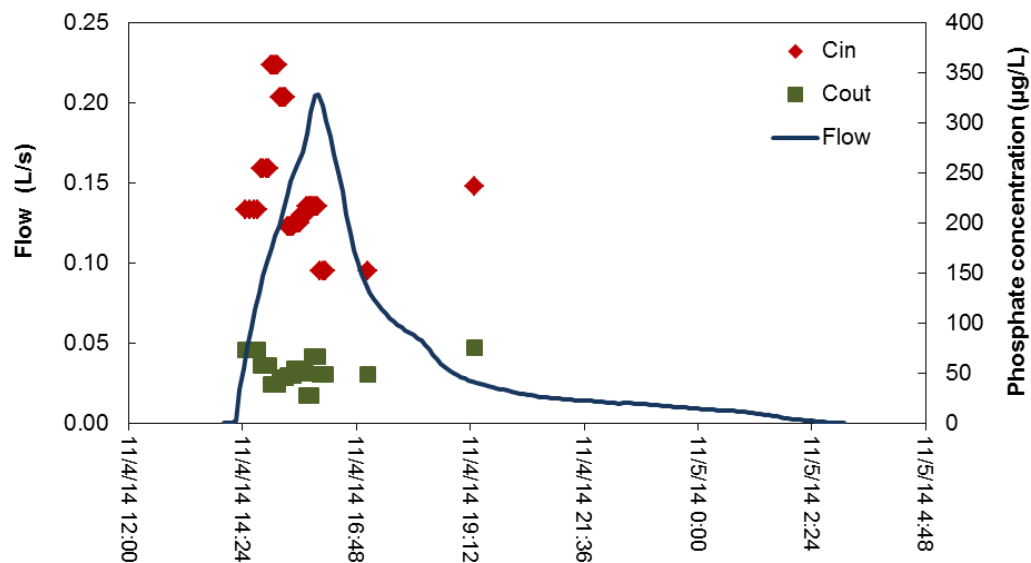
**Figure 13. Results of synthetic runoff testing at the MnDOT iron-enhanced swale ditch check site 2, on Nov 4, 2014. Cin and Cout denote influent and effluent concentrations, respectively.**

The measured filter outflow and pollutant concentrations at the iron-enhanced ditch check site 2 are shown in Figure 13. Each data point represents the average phosphate concentration in 20 L of synthetic runoff volume passing through the ditch check. The event mean concentration (*EMC*) of phosphate for the entire test is 206 µg/L in the inflow and 45 µg/L in the outflow. The retention of phosphate in the iron-enhanced ditch check resulted in lower outflow phosphate concentrations. The total mass input and output are 0.41 g and 0.089 g, which corresponds to 78% mass reduction through the iron-enhanced ditch check. The zinc *EMC* were 70 µg/L inflow and 62 µg/L in outflow (concentration was measured in one composited sample). The zinc mass input of 0.14 g was reduced to 0.12 g, which corresponds to 11% retention of zinc mass by the ditch check.

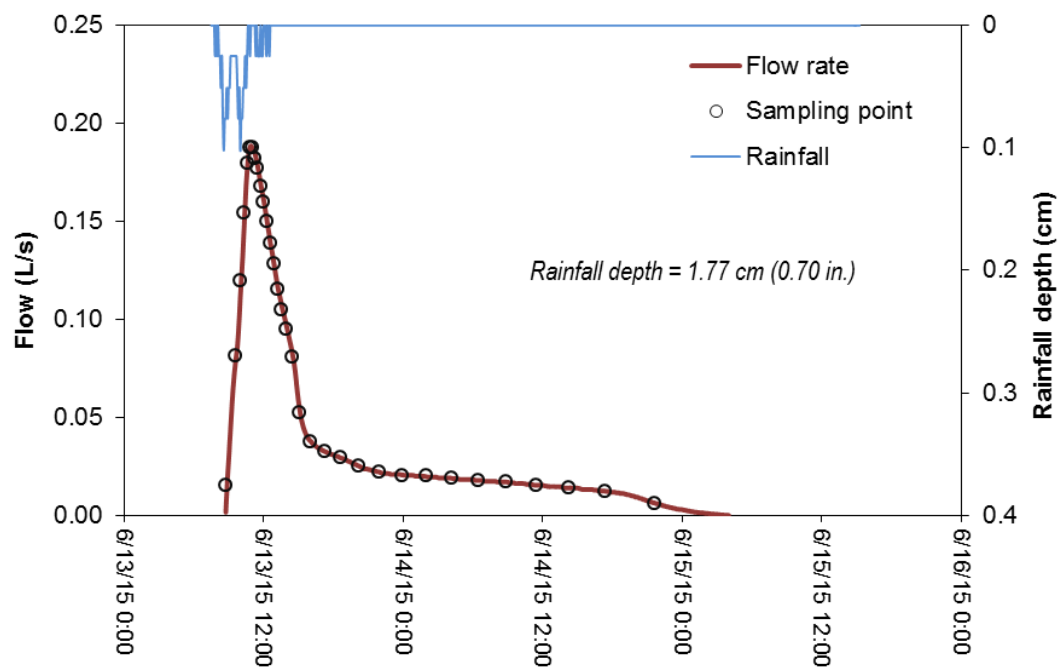
**Figure 14. Sample hydrograph recorded at the MnDOT iron-enhanced ditch check site 2 on June 14, 2015, rainfall event. The composite sampling regime is also shown in the plot.**

The events monitored at both sites had rainfall depths ranging from 0.76 to 10.7 cm (0.30 to 4.23 inches), and total rainfall durations between 0.75 and 28 hours. A sample hydrograph showing the recorded flow through the iron-enhanced ditch check during a water quality event is shown in Figure 14 as an example. Distribution of the water sample collection during the storm course is indicated in the plot. The same method was followed for the existing ditch check site (sample figure is thus not shown).

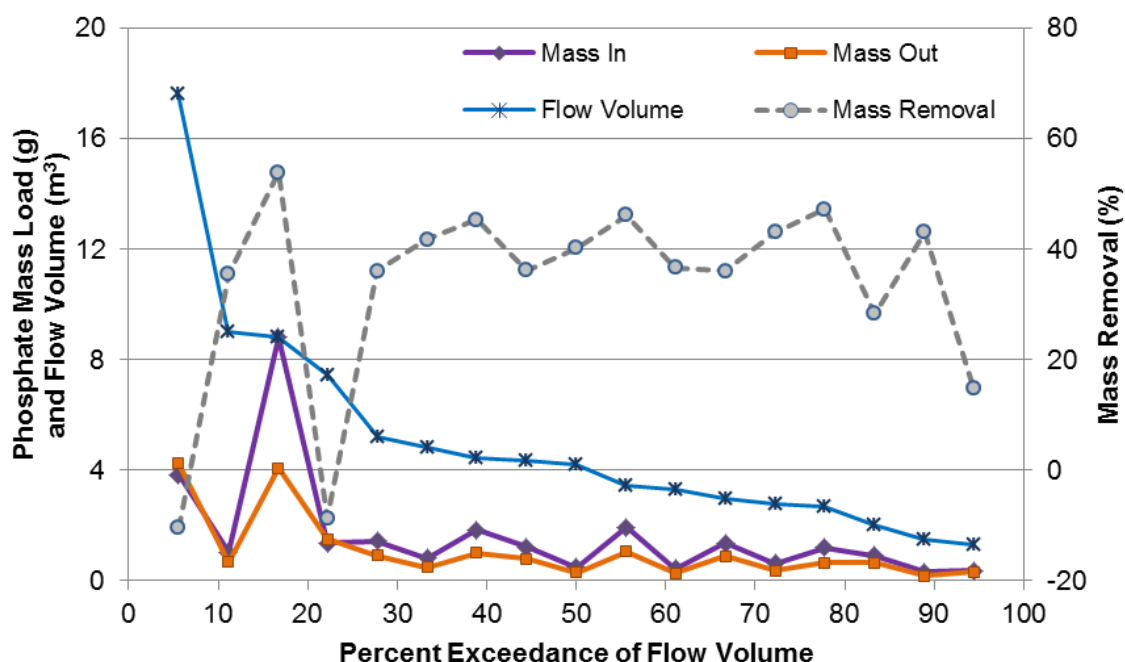
**Figure 15. Exceedance plot for flow volume and corresponding paired phosphate mass loads and mass load reductions at the iron-enhanced ditch check constructed in the MnDOT swales.**

of flow volumes ( $> 7000$  L) contributed variable phosphate mass load inputs. The corresponding mass load reductions were also mixed, with the highest flow volume producing negative mass removal and the next two flow volume magnitudes showed high load reductions. The influent phosphate mass was consistently removed for flow volumes less than 5000 L. The total mass load input from the 25% exceedance of flow volumes was greater than the combined load from flow volumes that have more than 25% exceedance probability (15 g vs 12.9 g). Based on the exceedance plot, the iron-enhanced ditch check can be expected to provide phosphate mass reductions when runoff volumes are less than 5000 L. Above 5000 L flow volumes, removal of phosphate could be mixed depending on the rainfall characteristics. For example, low versus high-intensity rainfall events determine the rate of runoff volume loading to the ditch check and influence the associated pollutant mass load distribution, and hence the overall mass reduction achievable through the iron-enhanced ditch check.

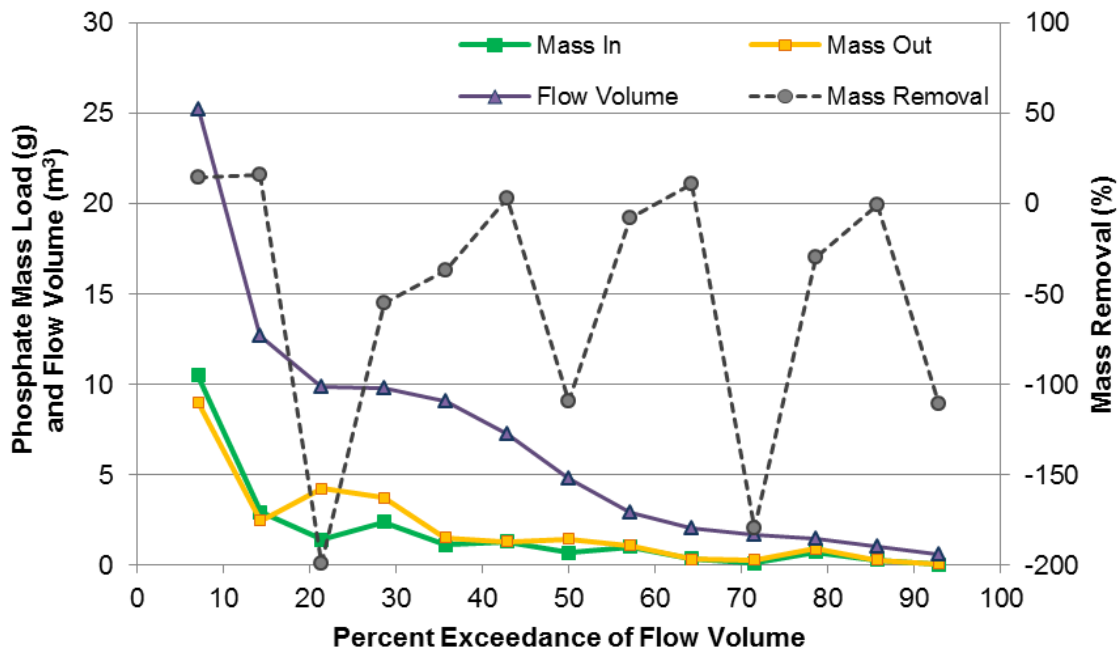
**Figure 16. Exceedance plot for flow volume and corresponding paired phosphate mass loads and mass load reductions at the existing ditch check in MnDOT swales.**

The existing ditch check generally showed very low or no retention of phosphates in runoff, as expected (Table 6 and Table 7). For the 13 events sampled, the influent phosphate *EMCs* were between 38 and 554  $\mu\text{g/L}$  (mean = 220  $\mu\text{g/L}$ ; median = 181  $\mu\text{g/L}$ ) and the effluent *EMCs* ranged between 79 and 631  $\mu\text{g/L}$  (mean = 284  $\mu\text{g/L}$ ; median = 292  $\mu\text{g/L}$ ) at this site. The phosphate mass removals measured ranged between -199% and 16% (mean = -53%; median = -30%), confirming the poor phosphate retention ability of ditch checks that do not contain specialized treatment media. The cumulative phosphate mass input and output were 22.7 g and 26.5 g, respectively, which means no net removal and 14% export of phosphate occurred at this site. This is confirmed by the flow volume exceedance plot (Figure 16); the influent mass load line is higher than the effluent line for flow volumes < 9880 L, which is greater than 25% exceedance flow volume at this site. A low phosphate removal occurred for <25% exceedance flow volumes. These two trends are contrary to the iron-enhanced ditch check performance.

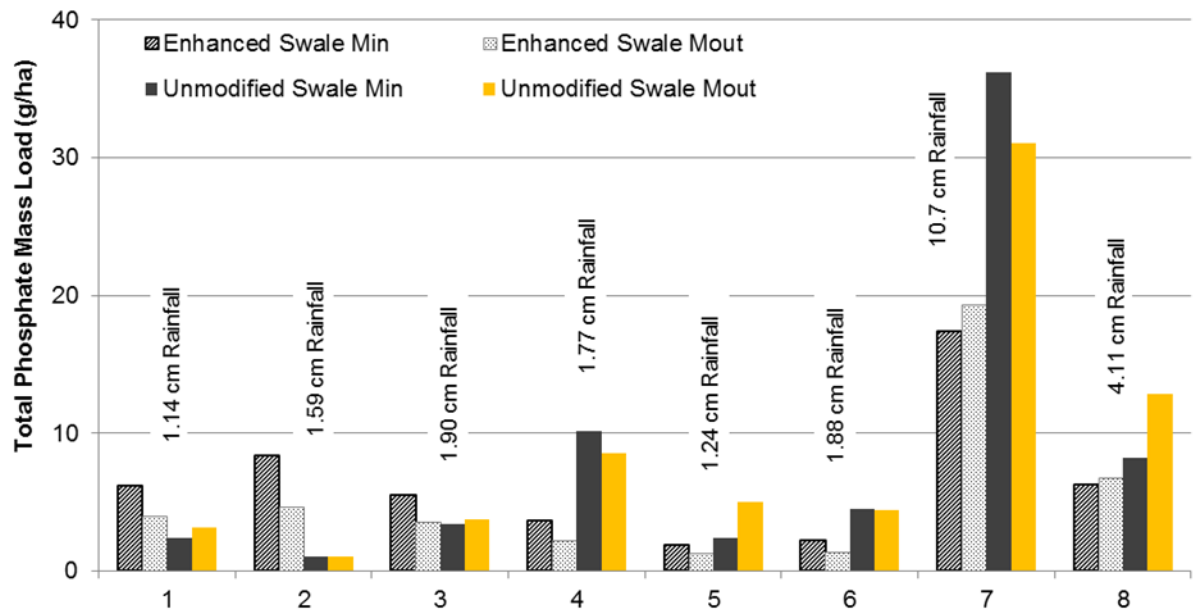
**Figure 17. Comparison of phosphate mass loadings at the enhanced ditch check and existing ditch check in the MnDOT swales for eight storm events monitored in 2015. The rainfall depths for each event is indicated.**

enhanced swale was much more effective in retaining the runoff phosphate mass inputs, except during the largest storms.

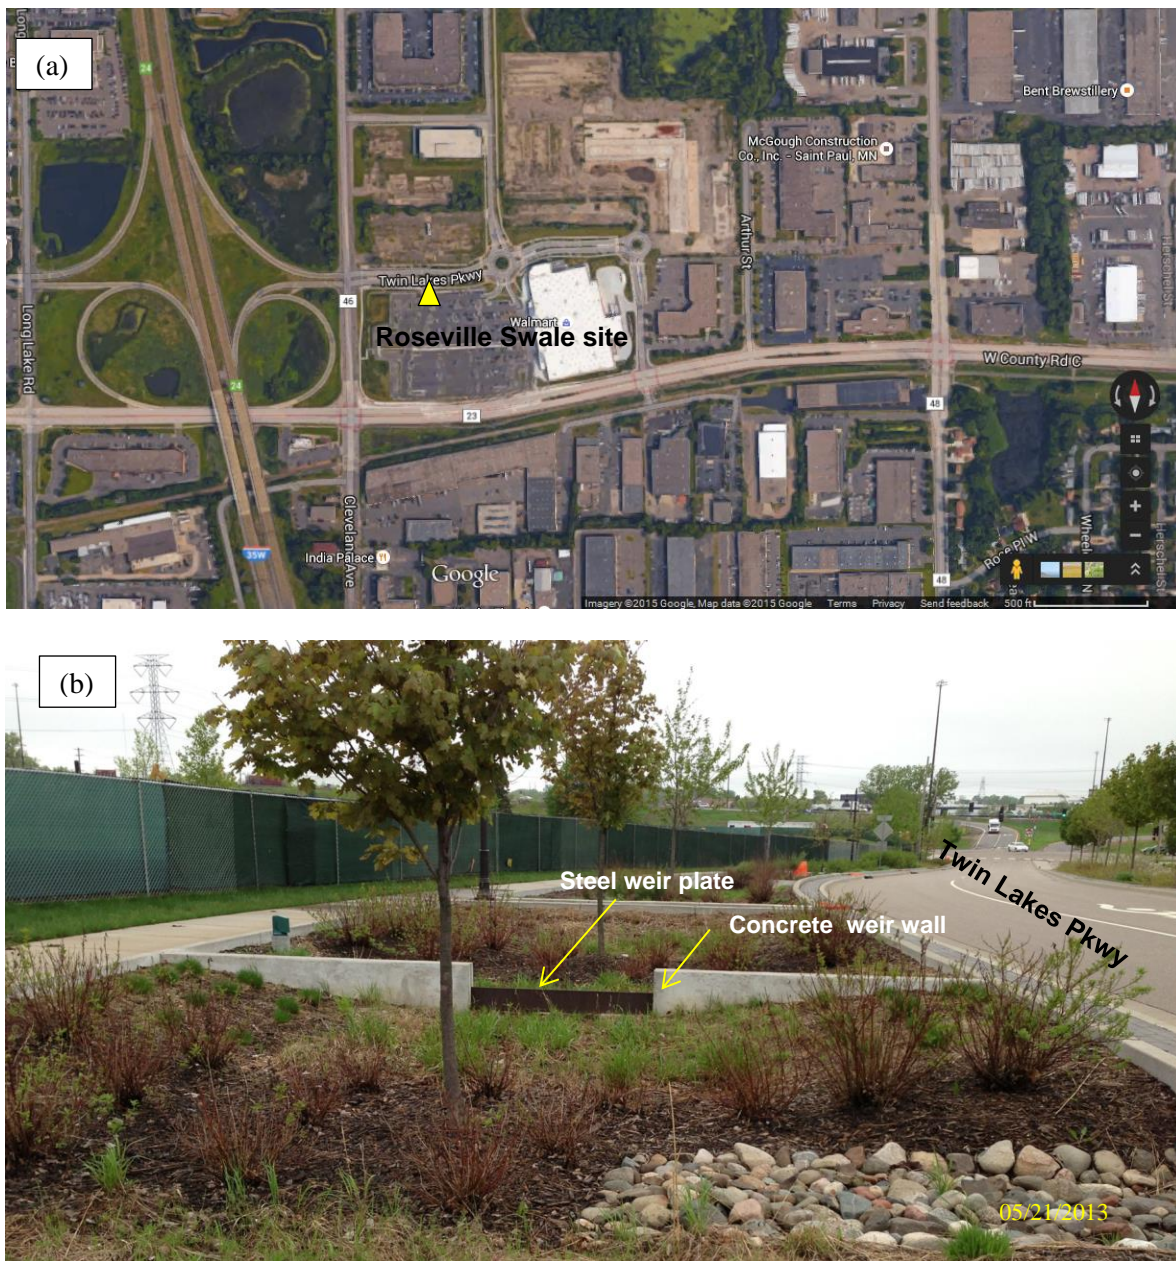
**Figure 18. (a) Map location and (b) Photograph of the Roseville swale basins along Twin Lakes Parkway, Roseville, MN (Note: Photograph does not show the location of iron-enhanced ditch check installed later).**

Swales located along Twin Lakes Parkway in Roseville were selected for the installation of iron-enhanced ditch check (Figure 18). The swales on the east and west side of the Parkway are part of the infiltration-stormwater reuse-irrigation system design employed at this location, under the right-of-way of the City of Roseville. The swales are divided into individual basins

The last swale basin on the east side of the Parkway was selected as the site for the iron-enhanced ditch check installation. The ease of access to the underdrain at this location was the primary reason for selecting this location for field testing purpose. The iron-enhanced ditch check was developed as an “insert”, taking into consideration the unique weir feature on site. The size of the test swale basin, measured from the upstream end to the weir location, is 11 m x 3.4 m (37 ft x 11 ft). The computed upstream volume of the basin is 16 m<sup>3</sup> (568 ft<sup>3</sup>), assuming uniform average basin depth of 0.43 m (1.4 ft). The drainage area to the test basin is not known since the basin receives runoff directly from the roadway as well as from the swale basins upstream via the underdrain.

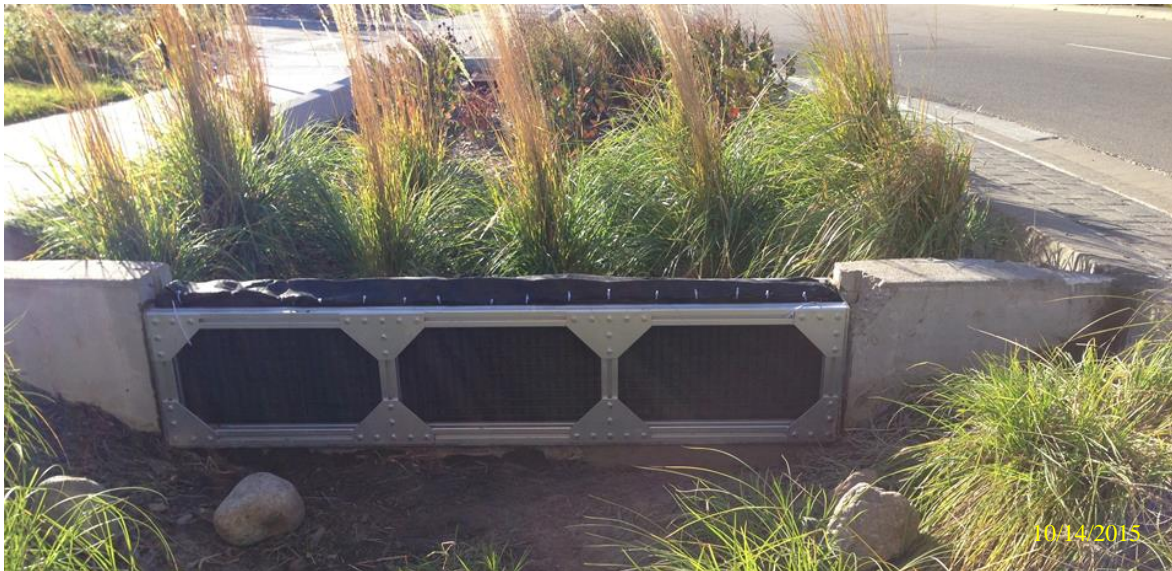
**Figure 19. Iron-enhanced ditch check installed at the Roseville swale basin.**

The ditch check was installed by the project personnel from University of Minnesota in September 2014. The existing steel weir was removed by the City of Roseville personnel prior to filter installation. First, the aluminum frame enclosure was installed in the concrete wall. The sides and bottom of the enclosure were made water-tight by applying a silicone-based sealant. The sealant was allowed to completely dry before installing the filter bags. After placing a sheet of geotextile fabric covering the interior of the frame enclosure (i.e. like a wrap sheet), the filter bags were packed inside the enclosure. Loose filter media was placed over each bag layer and filled in the gaps around the bags. Once the enclosure was full, the geotextile wrap fabric was folded over from the top and sealed to complete the filter assembly. The final dimension of the filter was 1.8 m L x 0.15 m W x 0.46 m H (6 ft x 0.5 ft x 1.5 ft). Photograph of the Roseville iron-enhanced ditch check is shown in Figure 19.

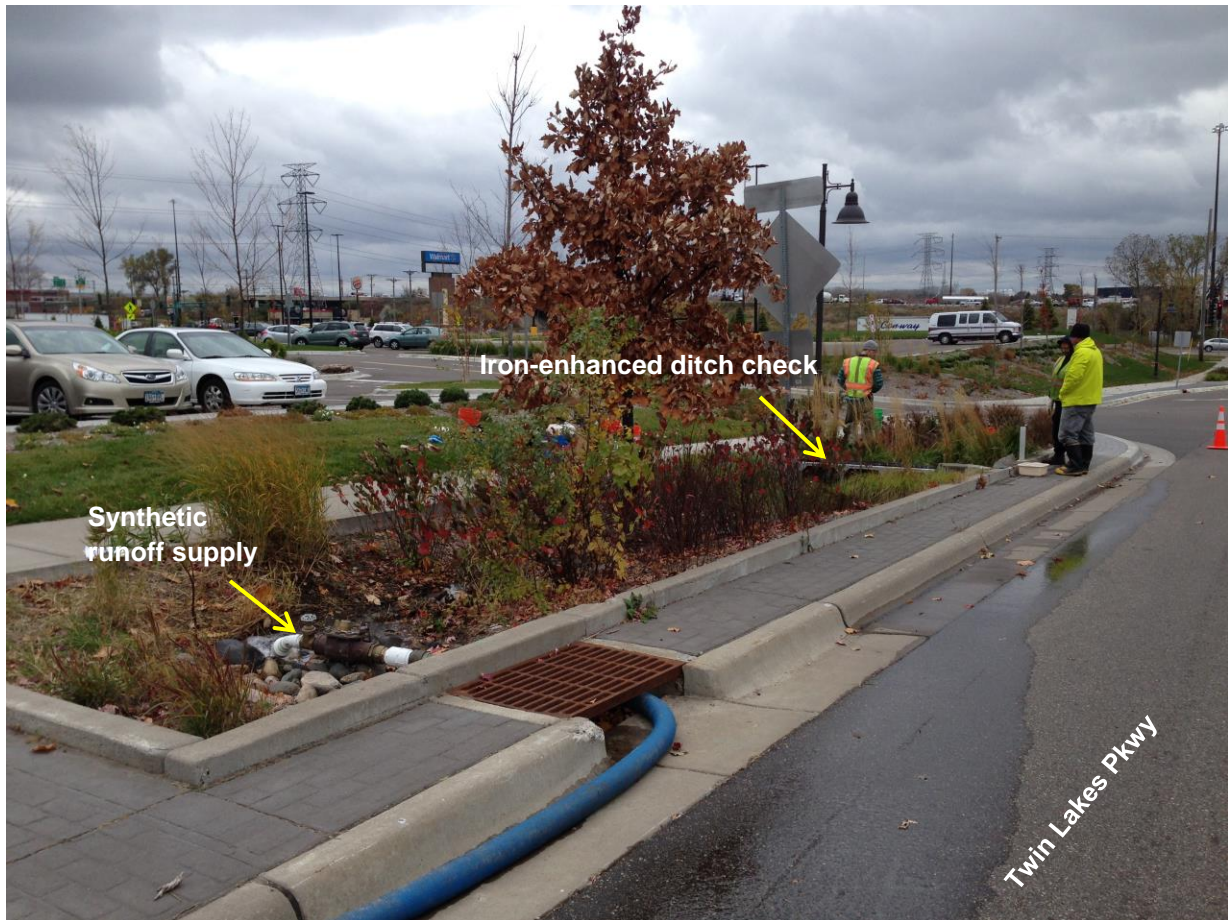
**Figure 20. Photograph showing the water truck testing conducted at the Roseville iron-enhanced ditch check site on 28 Oct, 2014.**

It was planned to determine the performance of the Roseville ditch check through field testing using synthetic runoff. A 7571 L (2000 gallon) -capacity water truck was used for the tests. The truck water was dosed with measured amounts of phosphorus and zinc to achieve a certain target concentration in the synthetic runoff; the target concentration was different for each test but was largely based on typical median pollutant concentration in urban runoff (Maestre and Pitt 2005). A hose with valve control was attached to the water truck spout to deliver the runoff. Water was introduced at the entrance of the swale basin, close to the catch basin (Figure 20). The quantity of water delivered into the basin was tracked throughout the test using a water meter attached to hose end. The water meter readings were taken every 5 or 10 minutes. The underdrain in the swale basin remained plugged throughout the test.

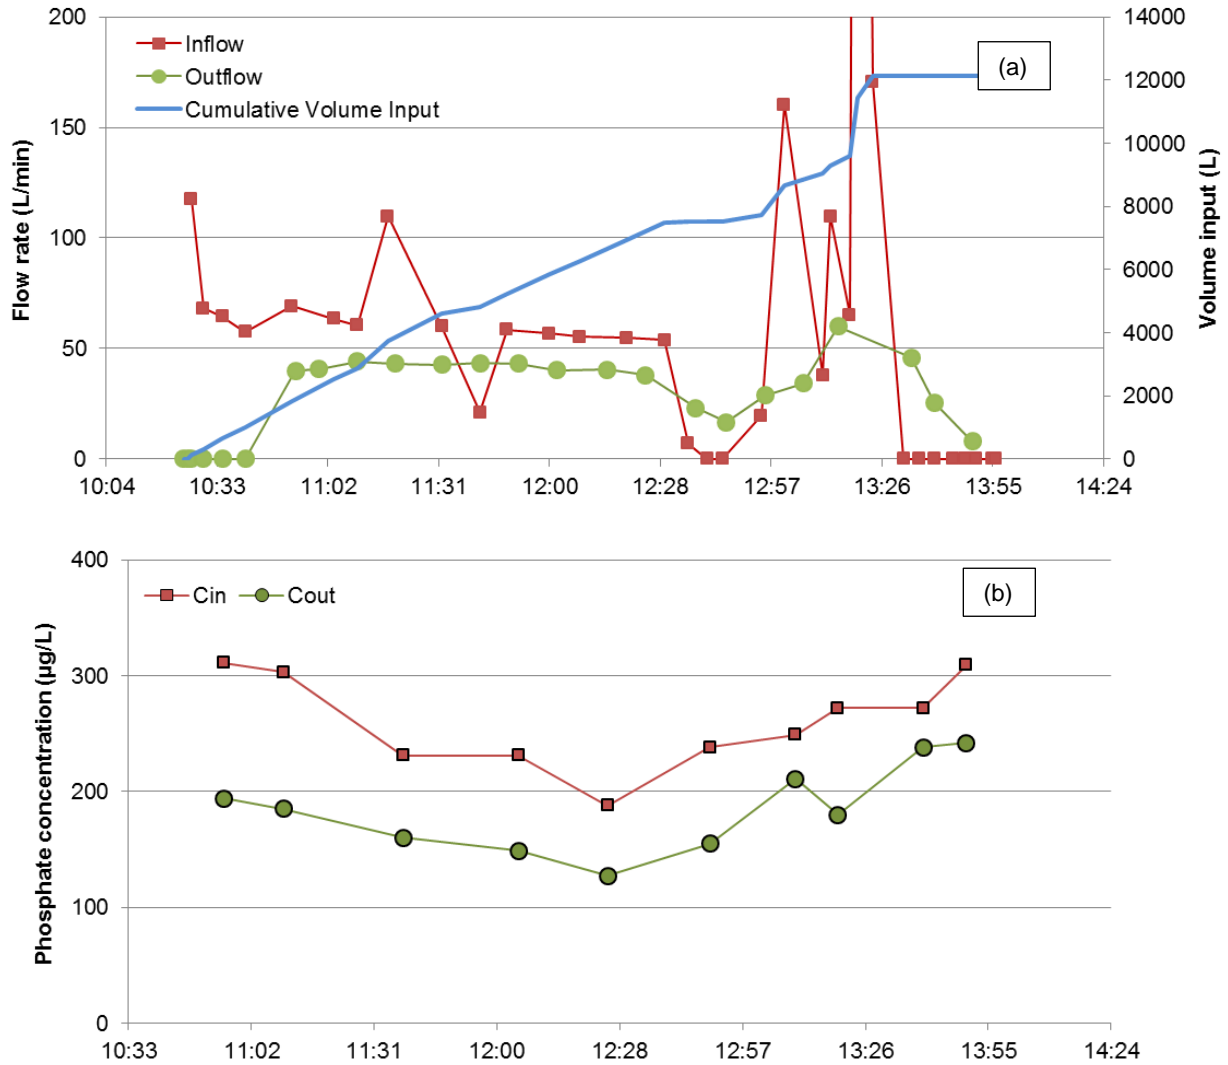
**Figure 21. Field testing conducted at the Roseville ditch check on 30 October, 2014: (a) Measured flow rates and input volume (inflow at 13:20 is out of the scale range); and (b) Measured sample phosphate concentrations (Cin and Cout denote concentration in the inflow and filter outflow).**
